Project: City of Wasilla WWTP Pilot Study Field Crew: Jake Alward, John Marshall

File: 204700415 Date: January 22, 2020

Reference: January Water Sampling Event

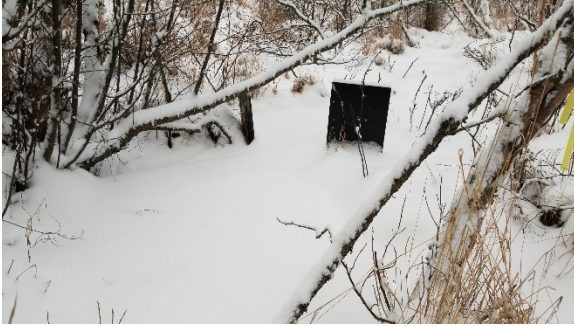
Photo 1:
SW17

The stream was open at SW17 and frozen at SW18. There was approximately 4 inches of ice that was drilled through to sample SW17. It also appeared the water depth at SW17 was very low. Flow measurements were not able to be collected at either gauging station as both were frozen.

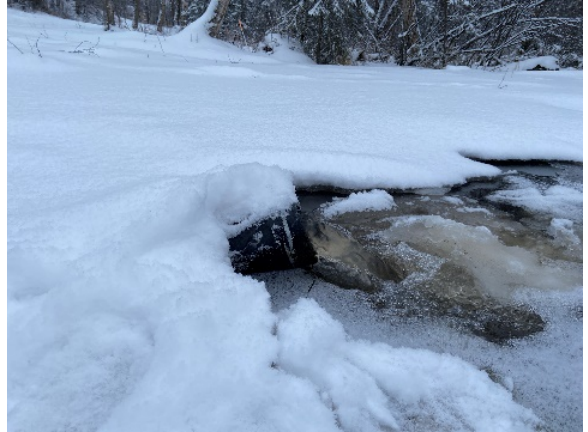
Photo 4:
Discharge Bed #1

The location immediately adjacent to discharge bed #1 was completely frozen. The ice dome that had been forming around the effluent pipe had disappeared. It appears the local water elevation in the area had risen approximately 4 inches, as the water level was just below the outfall pipe (see Photo 4). There is a small section of open water just downstream of the outfall pipe, however within 15 feet things are completely iced over. There does not appear to be any glaciation.

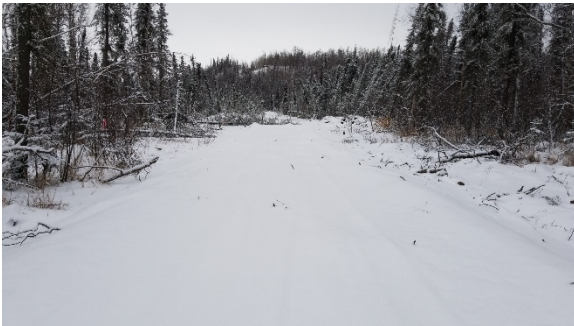
Photo 2:
Berm

The berm is nearly completely covered in ice and still has locations where overflow is apparent. There are no open channels from the effluent discharge to the berm. The overflow locations appear to be due to natural groundwater upwelling, which are common throughout the site. Two samples were taken along the berm to be sampled for nitrogen and ammonia.
