**AM No. 19-50: Contract Amendment To Big Dipper Construction In The Amount Of \$113,968 For The Wasilla Library Parking Lot Expansion Project.**

# Change Order

SUBJECT: Wasilla Public Library Parking Lot Expansion  
Geotechnical Recommendations  
Project Number 1122.63006.01

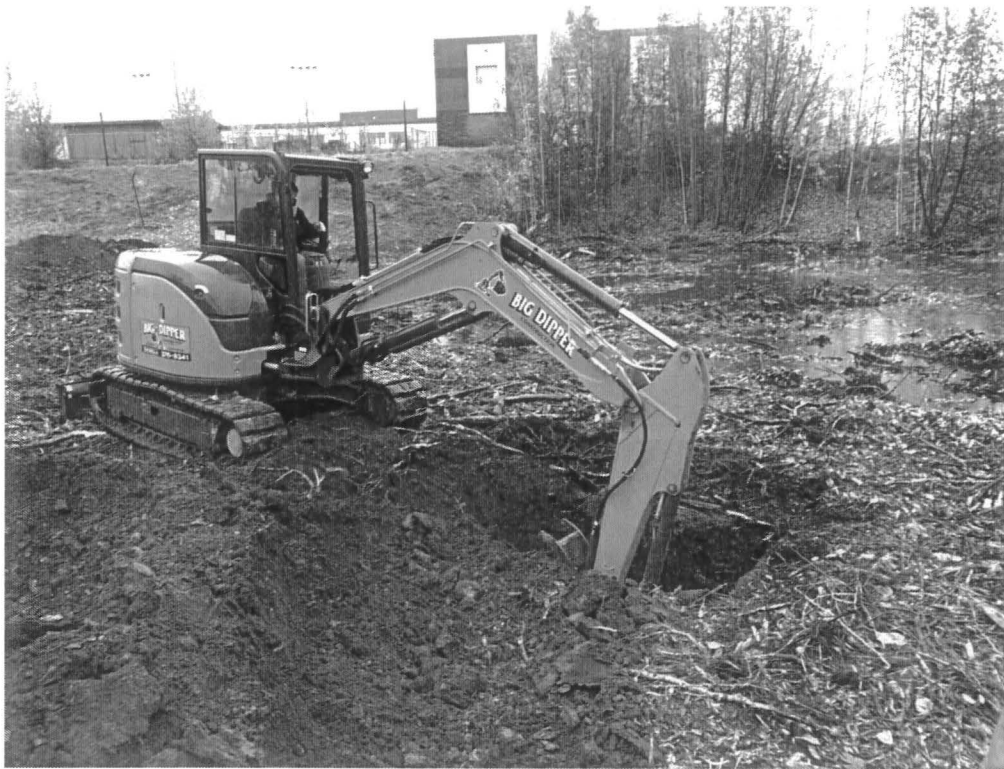
Surface. At the time of the investigation, the surface had been cleared of brush and trees. Six inches of standing water was present in the northwest corner of the parking lot. Standing water was present to depths of 6 to 12 inches along the entire western border of the site; more than 12 inches of water had ponded in the northwest corner of the property. Approximate extents of the pooled water at the time of the site visit is shown on the attached test pit location map (Figure 1). Photos of the pooling are also attached.

Excavator and ponding in NW of lot

Groundwater was not observed in test pits, however, water seeped in at the top of the peat layer and pooled in the base of the test pits. If the weather is wet and surface water is pooled on the site, dewatering will be necessary during the excavation. The contractor is responsible for determining dewatering methods and obtaining needed permits to discharge water.

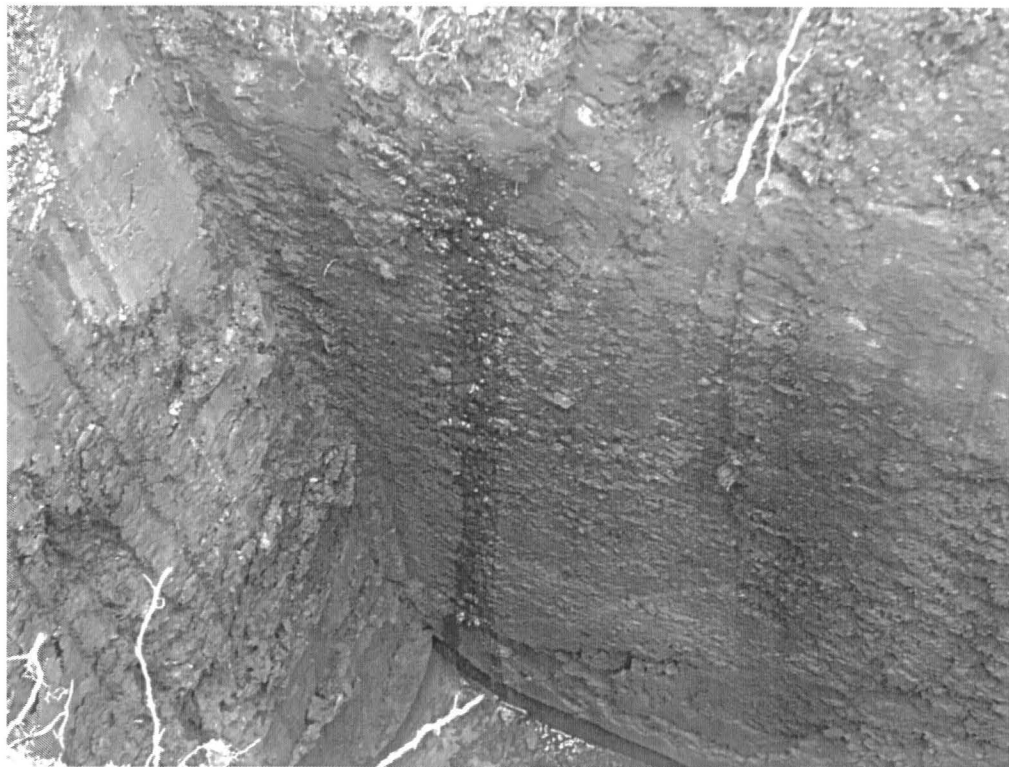
**Drainage Concerns.** We observed significant ponding on the site. The water appears to be surficial as groundwater was not encountered in the test pits. However, water does appear to be infiltrating through the fill and into the top of the peat as observed from the seepage in all four test pits (see photos). If water ponding on the site is not addressed, water movement through the fill may contribute to frost-related issues as frost depth in the area will penetrate through the fill and into the peat layer. Excess water within the fill will contribute to damage to the pavement in seasonal freeze-thaw cycles.

Water seeping from top of peat

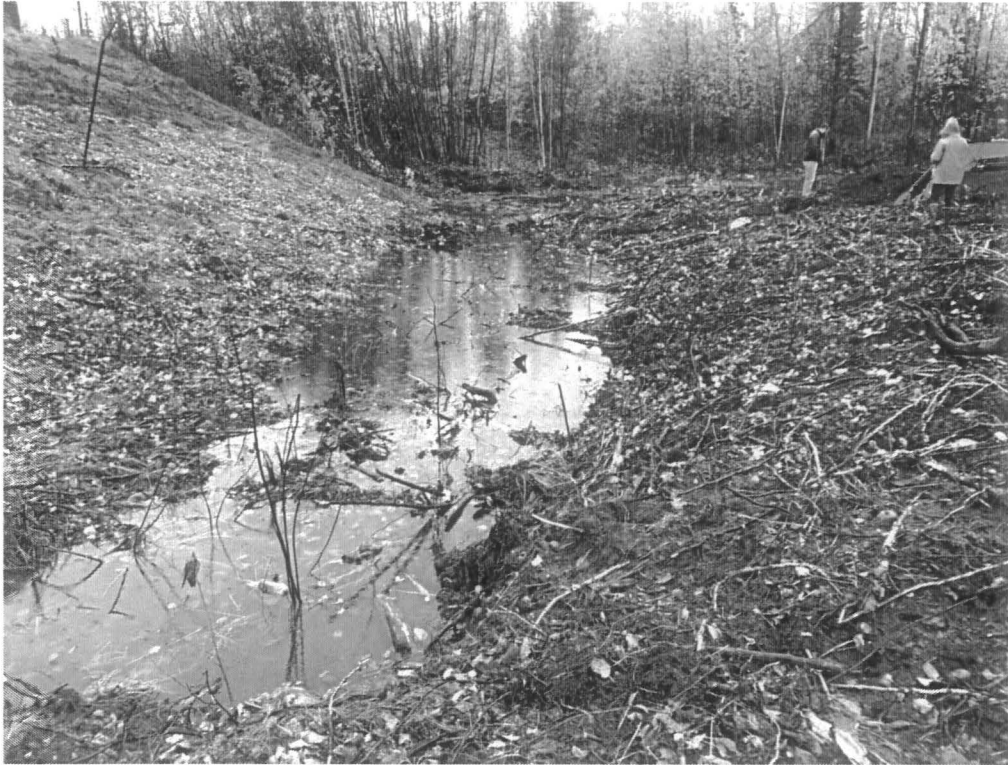
Water ponded along western border of site

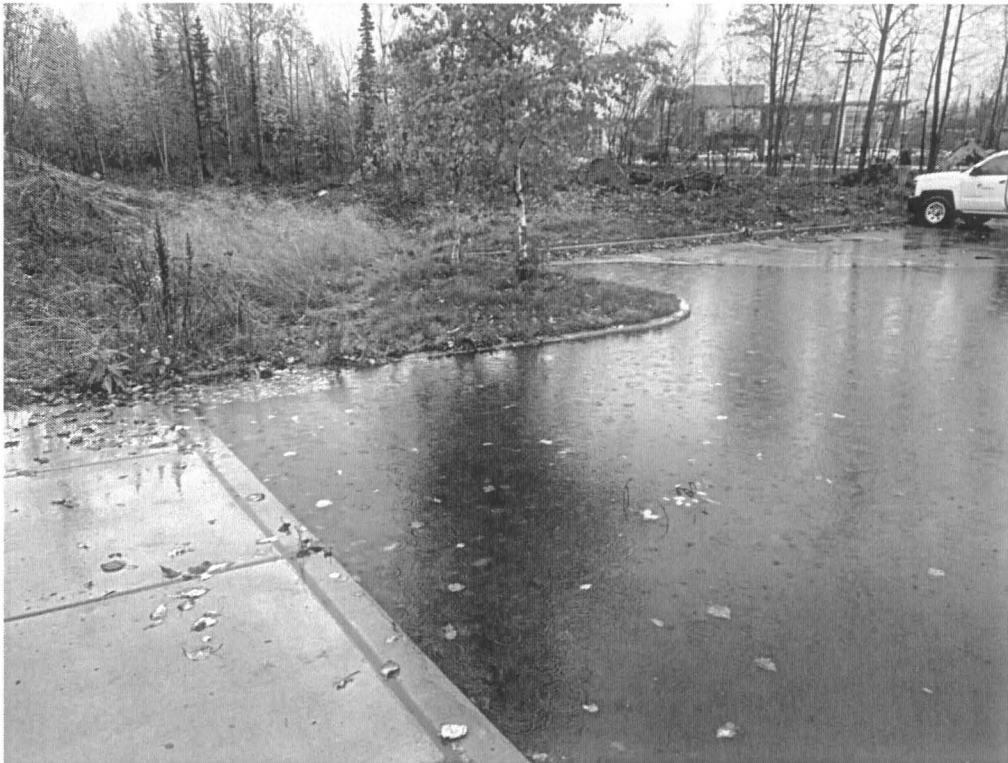
Water ponded in northwest corner of existing parking lot.

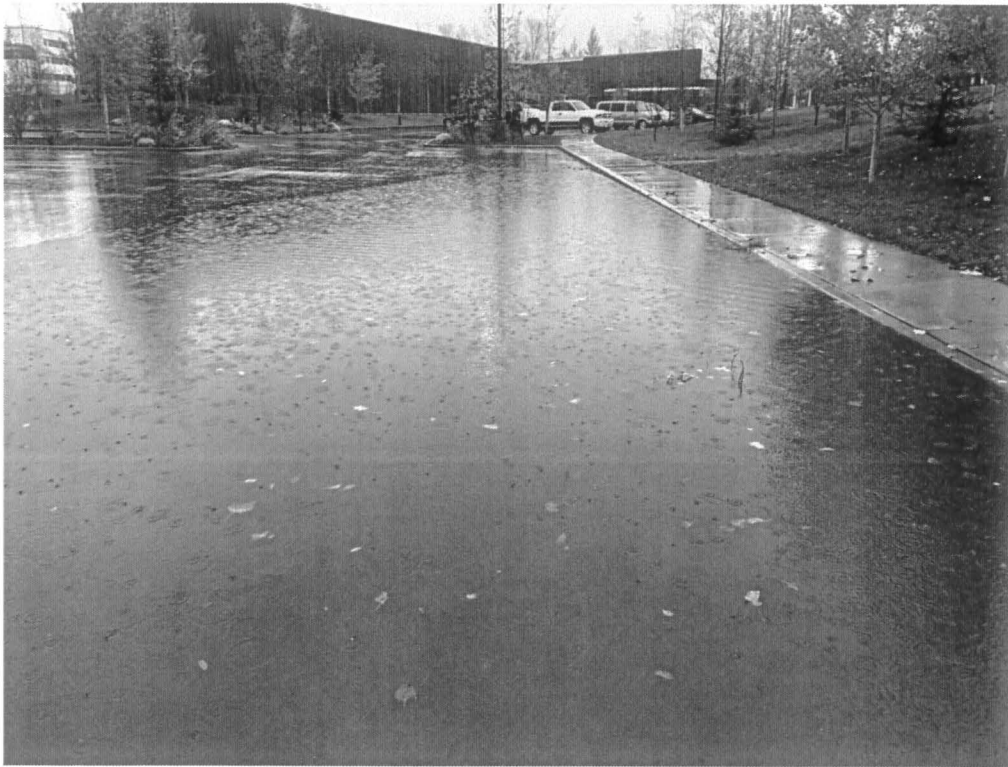
Water ponded in northwest of parking lot

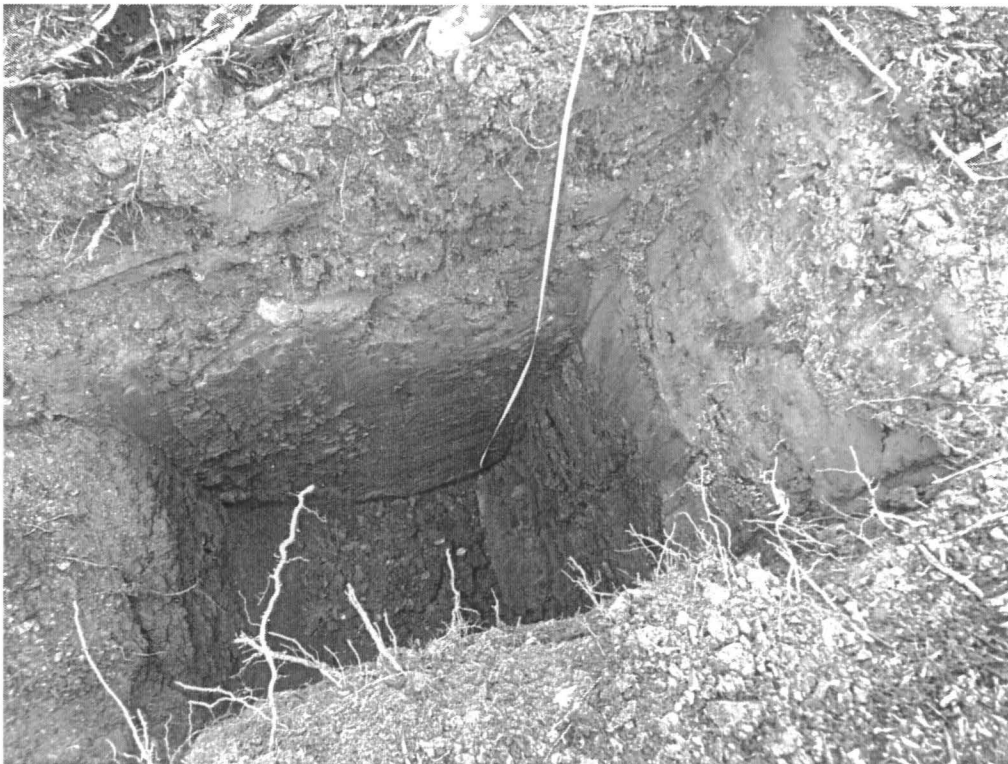
Subsurface. Based on the test pits, subsurface conditions are generally uniform within the proposed parking lot expansion. A six-inch-thick organic mat over two to four feet of fill material was observed in each of the test pits; the fill material classifies as silty sand with gravel. Below the fill material, four to six feet of peat is present over gray nonplastic silt; organic debris consisting of trees and roots are present at the fill-peat boundary, indicating the fill was placed directly over the original organic mat. Water was observed seeping into the walls of the test pits, approximately 6 to 12 inches below the top of the peat layer.

Typical soil profile for test pits; fill over peat over silt

The existing fill and peat are not suitable for support of pavements. We recommend the peat be removed and replaced with properly placed and compacted backfill material.

Remove all peat to expose the underlying silt layer. Scarify and compact the bottom of the excavation prior to placing backfill. The existing surficial fill may be reused as backfill. A material meeting the State of Alaska Department of Transportation, Select Material Type C with the fines content limited to 20% passing the number 200 sieve may be used to backfill the excavation up to the bottom of the following recommended structural section:

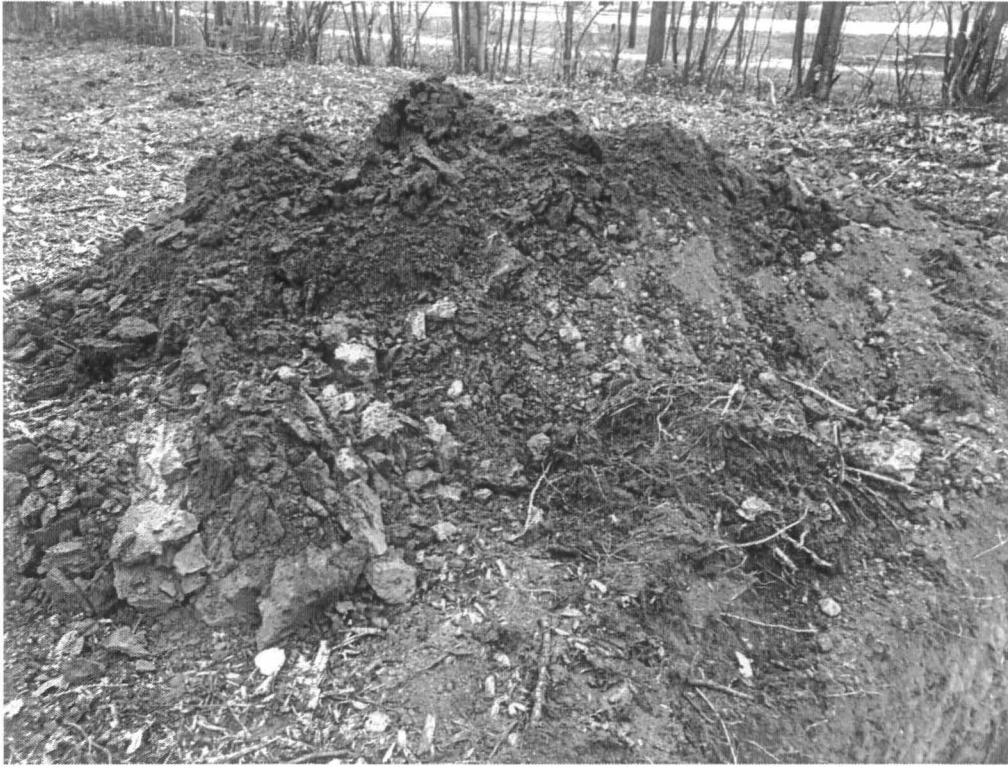
Typical soil on the parking expansion site: silt on bottom left, peat on top, fill material on bottom right

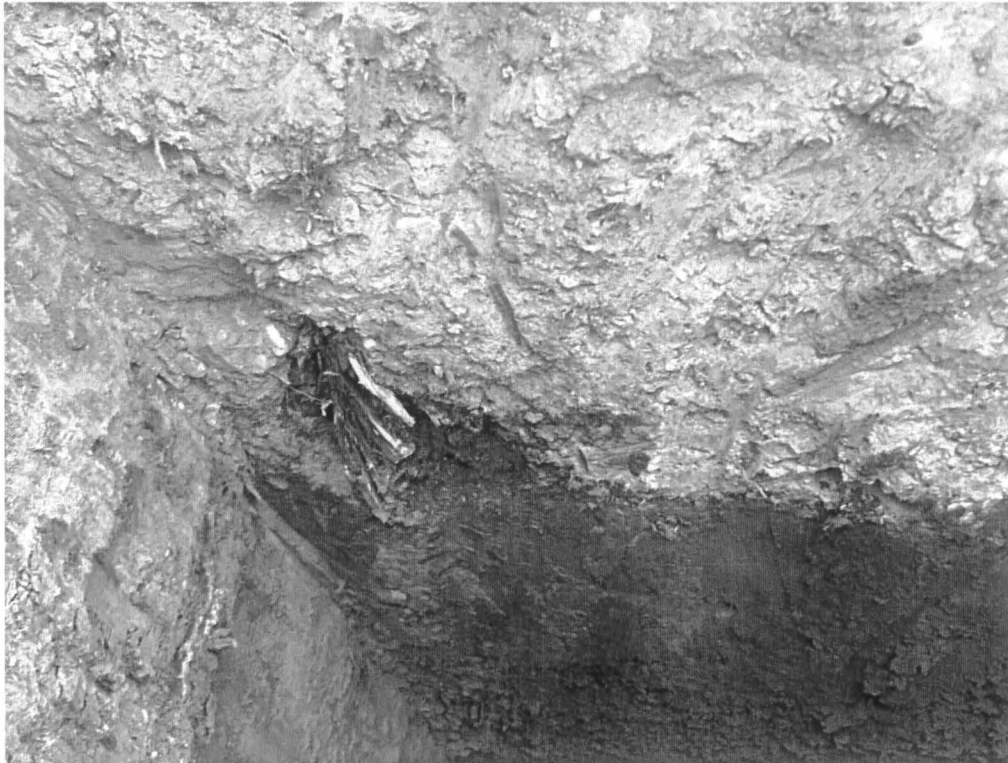
Large organics present at top of peat layer

If the partial excavation alternative is selected, overexcavate the peat and fill to at least 4 feet below final grade. If any large (greater than ½ inch in diameter) organic matter is encountered at the bottom of the excavation, continue to excavate until all large organic matter has been removed.
