Project:	City of Wasilla WWTP Pilot Study	Field Crew:	Cindi Pannone, Riley Bronga, John Marshall
File:	204700415	Date(s):	September 26, 2017 to September 27, 2017

**Reference:    September Water Sampling Event**

## September Photo Log

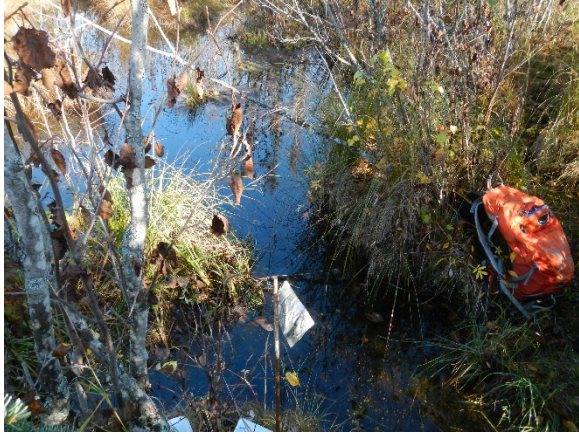
Photo 1:  
Pond at SW5

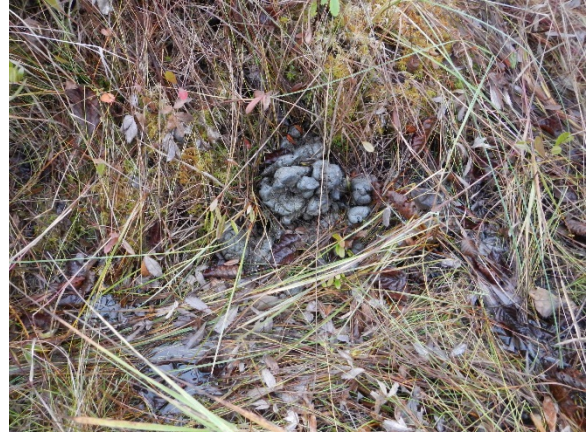
All 18 surface water sites were sampled over the two days. Weather ranged from clear and sunny to cloudy, but there was no rain. The terrain was no drier resulting in typically rough terrain (Photo 1 & 4). SW4 and SW18 were duplicated and labeled D1 and D2 respectively. There was a lot of animal waste observed (Photo 2) which is to be expected.

Photo 4:  
Evidence of animal presence

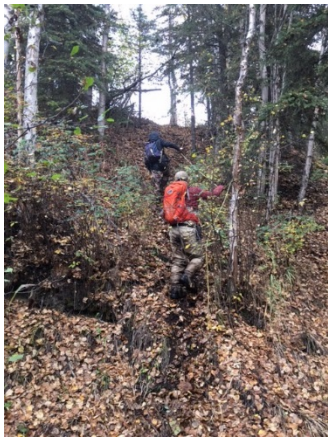
Two safety concerns were noted on this sampling event. The first item being that there are some locations that appear to be upland when they are really sink holes (Photo 3). This is especially deceiving when the ground is covered in leaves. The second item is access to SW18 requires descending a steep hill (Photo 2). There is a rope strung between trees; however, the rope is abrasive and can easily cut skin if gloves are not worn.

Photo 2:  
Steep hill access to SW18

- Clarify with lab the bottle count for future sampling events
- Bring a tape measure to record width of weir (if there is concern it has changed)
- Extra caution must be taken when working on this job site. It may be helpful to use walking pole when maneuvering the site. Gloves should be used when descending the hill.

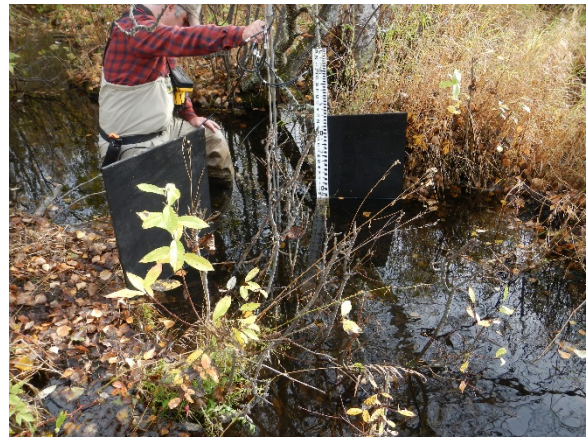
Velocities and depth of water at weirs 1 and 2 were collected (Photo 4). Using the previous width of the weirs, stream flow was calculated.

Width: 2.21' (from original installation)  
Water depth(s): Middle stream – 0.81'  
Velocity: 0.24 ft/sec  
Calculated flow: 0.43 CF/sec

Photo 4:  
Stream gage station SW17

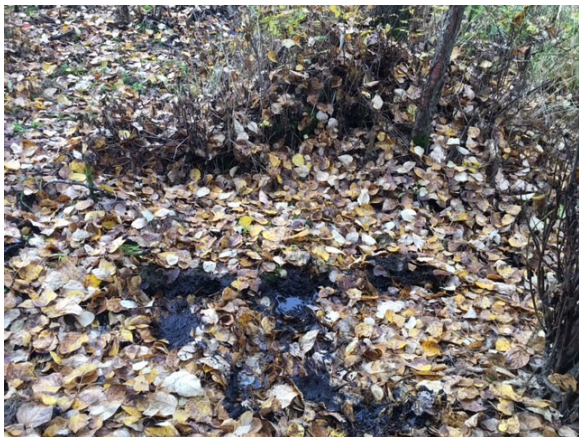
Photo 3:  
Sink hole covered with leaves

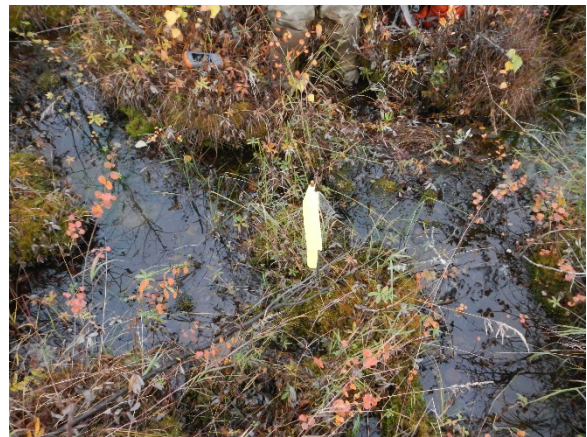
Photo 4:  
Surface water present at SW13
