Project:	City of Wasilla WWTP Pilot Study	Field Crew:	Jake Alward, John Marshall, Cindi Pannone, Riley Bronga
File:	204700415	Date(s):	December 12, 2017 to December 13, 2017

Reference: December Water Sampling Event

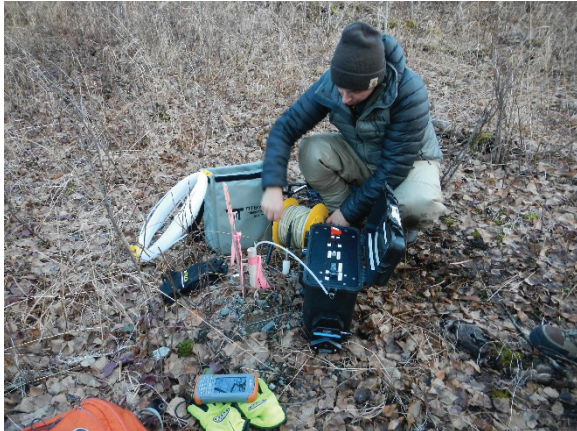
Water was only sampled at four surface water locations, two at the creek and two at existing ponds. Five of seven subsurface locations were sampled (Photo 1).

Photo 1:
B4 sampled using a peristaltic pump

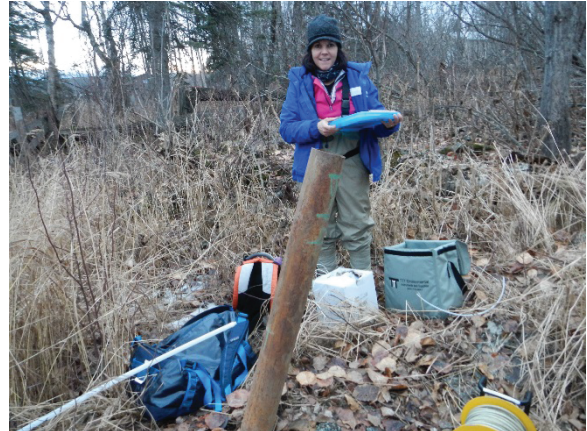
Subsurface water was not sampled at B11 and MW14. MW6 had an ice plug that almost prevented sampling, but it broke loose and floated to the top of the casing (Photo 3). B11 was frozen and MW14 is damaged. The protective casing at MW14 is bent at a 30° angle and the cap is pulled off (Photo 2). The water depth tape was not even able to navigate the bend in the well casing.

Photo 2:
MW14 pulled over at 30° angle

- MW14 needs to be fixed
- B3 needs a new cap (Photo 5).

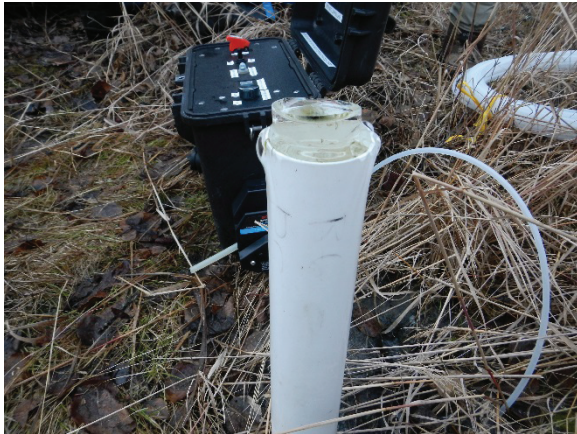
Photo 3:
MW6 with a floating ice plug

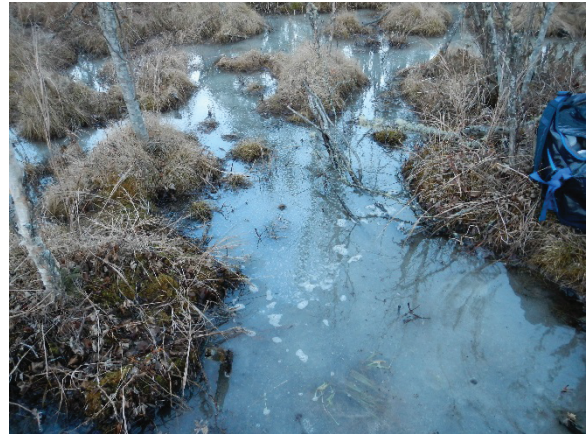
December's sampling event included both surface and subsurface sampling. The site was much different than November's sampling event. Nearly all the snow was gone, ground was more frozen (Photo 4), and there was approximately an 1" of water lying on top of all the ice in the swamp. Depending on the location, the source of the water on the ice was either ground water or precipitation. The weather was cloudy and 41°F.

Photo 4:
Site is frozen

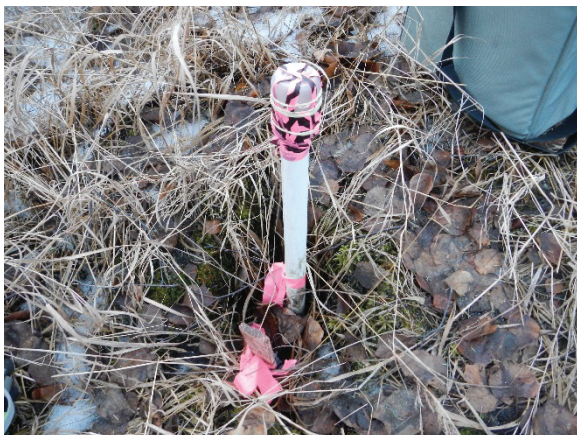
Photo 5:
B3 with a makeshift cap

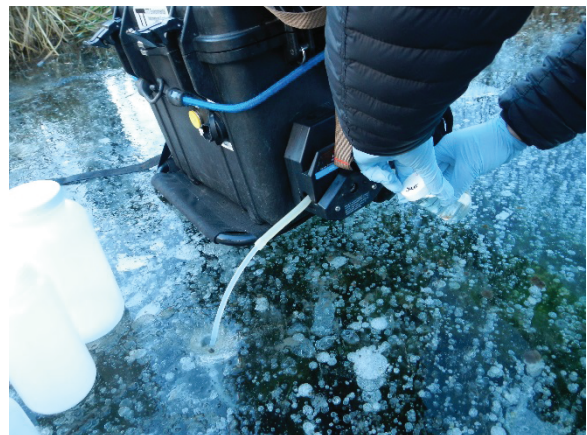
SW5 was sampled using a peristaltic pump through a 1" hole drilled through the ice (Photo 6). Ice thickness was determined by drilling a 1" hole through the ice at each sampling location with an 18" drill bit.

Photo 6:
Hole drilled through ice for peristaltic pump
