Project: City of Wasilla WWTP Pilot Study      Field Crew: Jake Alward, John Marshall  
File: 204700415      Date: February 16, 2018  
Subsurface     Surface     Vegetation Plot

**Reference: February Water Sampling Event**

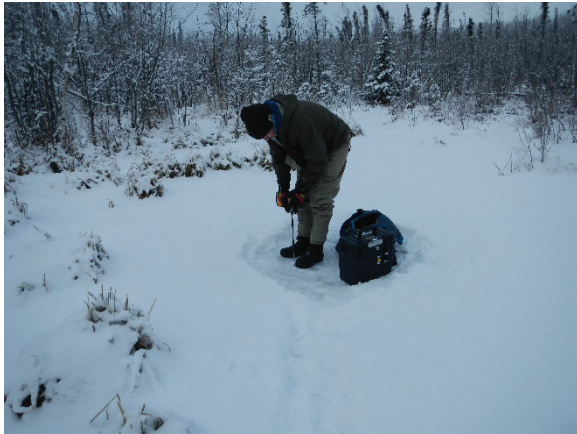
Photo 1:  
Sampling pond at SW5

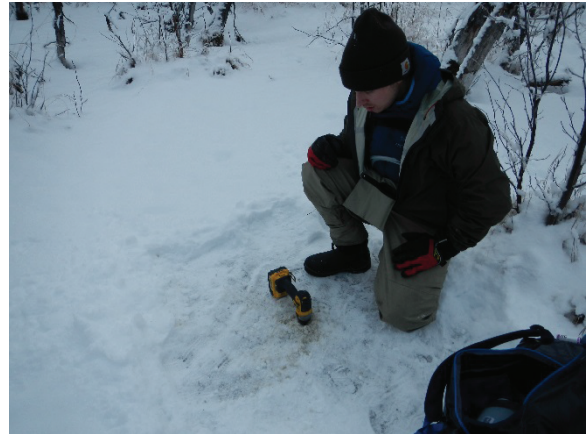
The site was substantially colder than it was in January 2018. The only apparent open water was at the toe of slope below the percolation beds. Surface water was only sampled at three locations, as the pond at SW-15 had ice thicker than 28", the max length of the drill bit (Photo 3 & 4). The pond at SW-5 had a total of 28" of ice, which was able to be penetrated by the drill bit (Photo 1). The stream at SW-17 was open and able to be sampled by dipping bottles into the stream (Photo 6). SW-18 was completely frozen (Photo 5), therefore a hole had to be drilled through the ice to collect water. At this location, ice was about 5 inches thick with running water underneath. Ice depths were not collected at any other locations.

Photo 4:  
Drill bit length maxed out AT SW15

We brought the largest drill bit we could buy at the store. It is likely that the ice will continue to thicken in the next month. It is possible that the only water accessible next month will be at flowing water, SW-17 and SW-18.

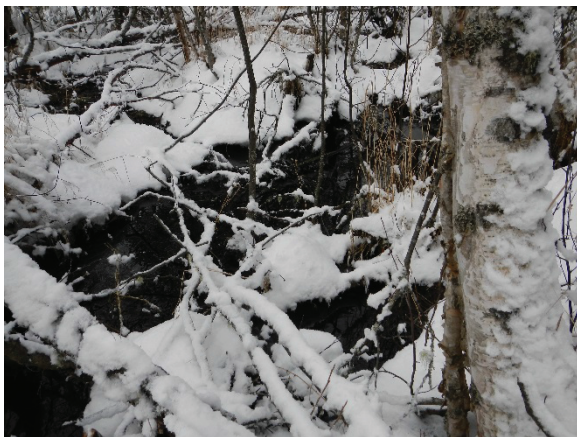
While walking to SW15, the origin of the stream was discovered (Photo 2). We believe the water from the percolation beds found an easy flow route to that location, which resulted in the start of the stream. It was previously believed that the stream was the collection of all the water in the wetland converging, however it may be more a function of the percolation beds. It will be interesting to see if that location dries up when the percolation beds are taken offline.

Photo 2:  
Origin of stream

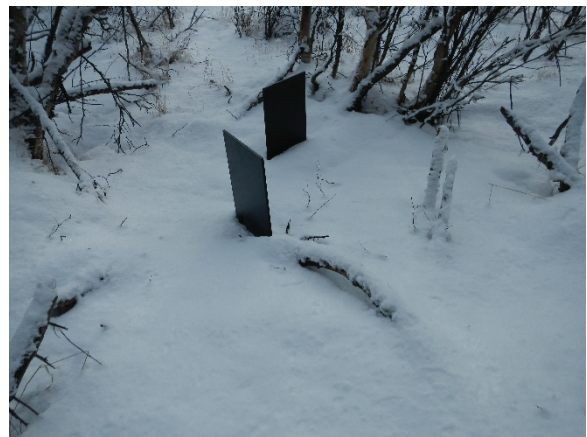
This event went smoothly as there were only 3 sample sites that were collected. The one discrepancy was that the stream gage at SW18 was still frozen, so flow was not measured at this site for this event (Photo 4). Water was able to be sampled as a hole was drilled through the ice, so the peristaltic pump could be used.

Photo 5:  
Stream gage station at SW18

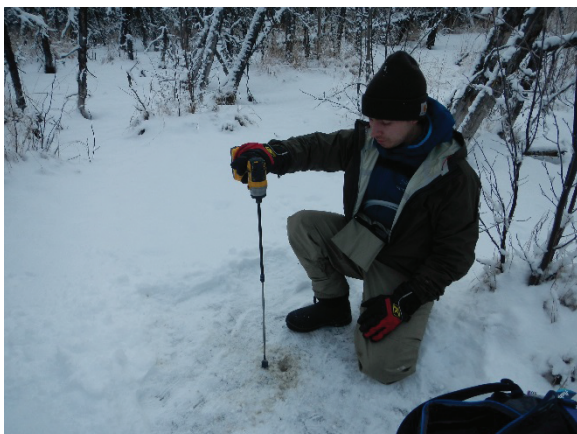
Photo 3:  
Full drill bit length at SW15

During the drilling at SW-15 a drill bit was lost in the ice. The location it was lost was marked with a tree branch to see if it can be recovered when some of the ice melts.

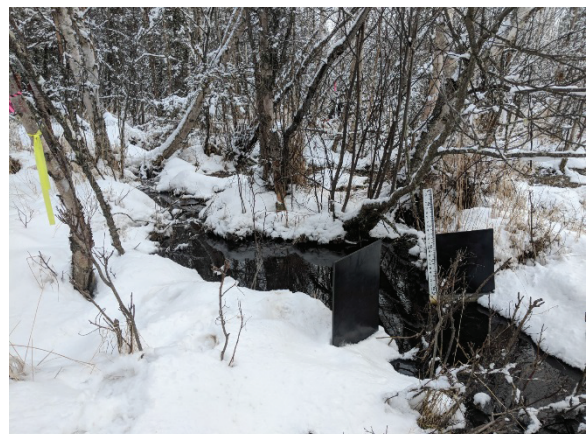
**1.3 OTHER ACTIVITIES**
Weir 1 (SW17)

Width: 2.21 -ft

Water depth: 0.7 -ft

Velocity: 0.3-ft/sec

Calculated flow: 0.46 -CF/sec

Photo 6:  
Stream gage station at SW17
