Project: City of Wasilla WWTP Pilot Study      Field Crew: Jake Alward, John Marshall  
File: 204700415      Date: April 24, 2018 and April 26, 2018

**Reference:**    **April Water Sampling Event**

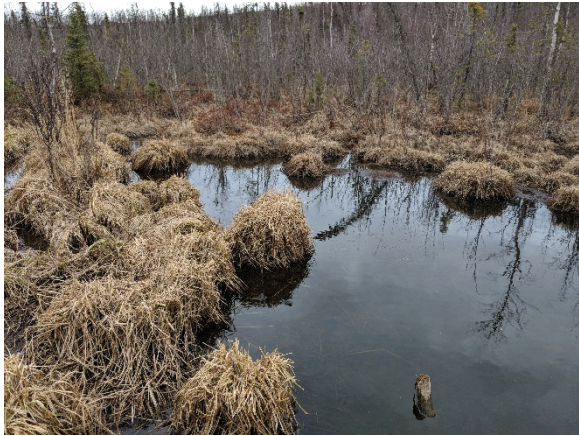
Photo 1:  
Pond at SW5 thawed

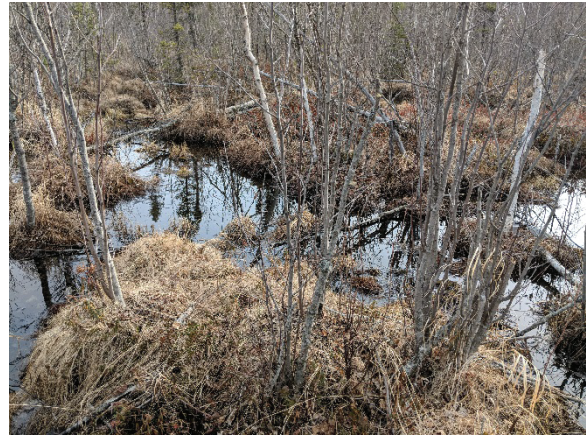
Photo 4:  
Surface appears to be completely thawed

The final activity of the sampling event was to sample two locations where we believed there was percolation bed seepage and one sample at the lagoon effluent (see photo 4).

14 of the 18 surface water locations were sampled. The water samples are thought to be typical of a spring break up. The ground had not yet completely thawed, although there was no ice or snow left visible on the surface (see photos 1-6). The water sitting on frozen ground is believed to be a combination of ground water and melted precipitation. It was apparent in a few locations that the ground water was upwelling to the surface because there were holes in the ground that were thawed to a depth greater than 4 feet.

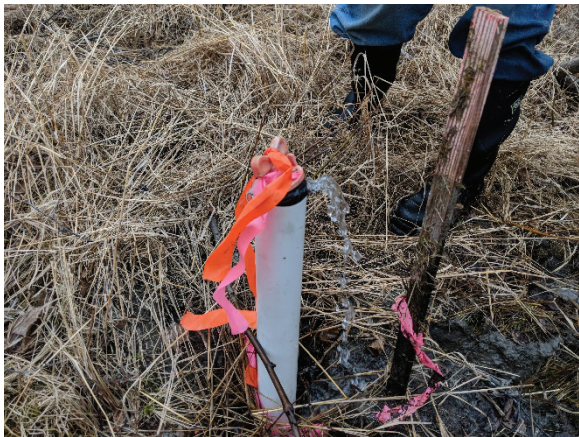
Photo 2:  
Monitoring well thawed

Surface water was sampled on two days. Not all sites were sampled as there was not enough water at some locations. In addition to surface sampling, we attempted to develop MW20. It was also observed the majority of monitoring wells were thawed and they all would definitely be ready to be sampled by the June sub-surface sampling event (see photo 2).

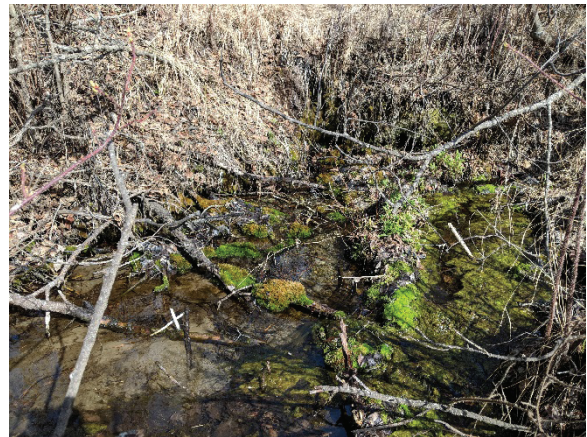
Photo 5:  
Seepage location #1

The lagoon effluent water was sampled at the effluent manhole to compare it to two locations thought to be percolation bed seepage. The first seepage location sampled was at the toe of the hill, but not yet to the stream. The second location was southwest of percolation bed 9. At this location, water was trickling out of the sloped surface. This location appears to be the start of a developed stream.

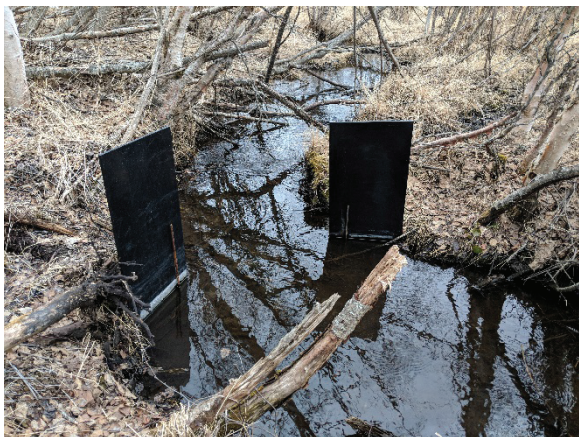
Photo 3:  
SW18 thawed

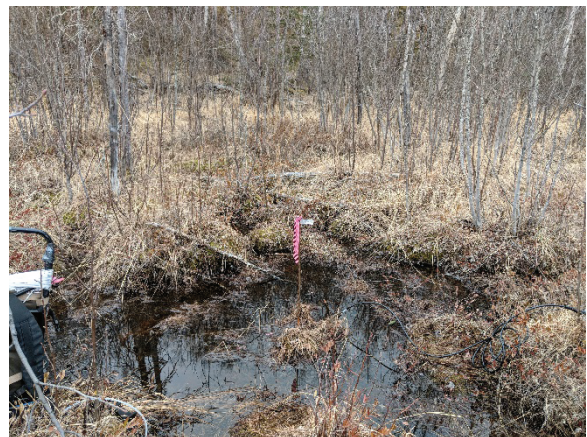
Photo 6:  
Pond at SW15 thawed
