Project: City of Wasilla WWTP Pilot Study Field Crew: Jake Alward, John Marshall

File: 204700415 Date: August 28-29, 2018

Subsurface Surface Vegetation Plot Lagoon

Reference: August Water Sampling Event

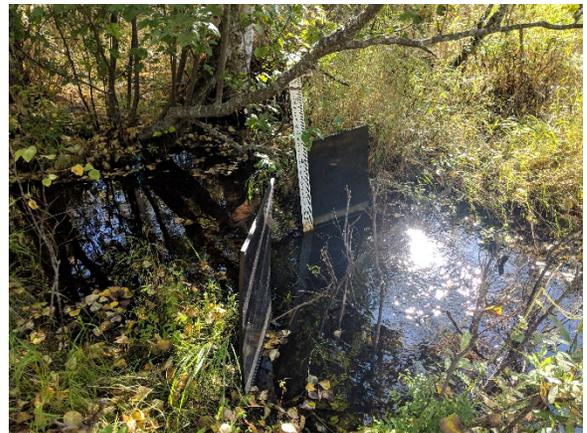
Photo 4:
SW-17

WEIR 1 (SW17)

Width: 2.21 -ft
Water depth: 0.70 -ft
Velocity: 0.45-ft/sec
Calculated flow: 0.69 -CF/sec
