Project:	City of Wasilla WWTP Pilot Study	Field Crew:	Jake Alward, John Marshall, Riley Bronga
File:	204700415	Date:	December 18 &19, 2018

Reference: December Water Sampling Event

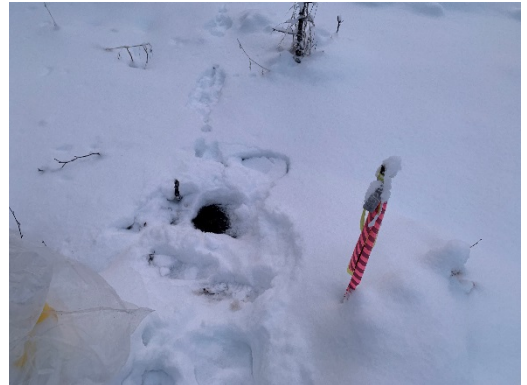
Photo 5:
SW-11

At all the sampling locations the surface water was completely frozen, except for SW11. SW11 had some snow and slush, but no thick ice. The other locations varied, but in general the soil under the surface water was also frozen to some degree. It is predicted that the soil will continue to freeze as cold conditions are maintained over the winter, although there was not a noticeable difference between November's sampling event and this sampling event. If anything, the southern section seemed to be more thawed.

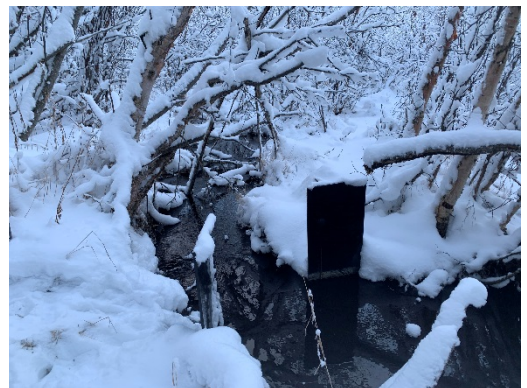
Photo 6:
SW-18

Width: 3.22 -ft
 Water depth: 0.7 -ft
 Velocity: 0.41 -ft/sec
 Calculated flow: 0.92 -CF/sec
