Project: City of Wasilla WWTP Pilot Study      Field Crew: Jake Alward, John Marshall

File: 204700415      Date: January 23, 2019

**Reference: January Water Sampling Event**

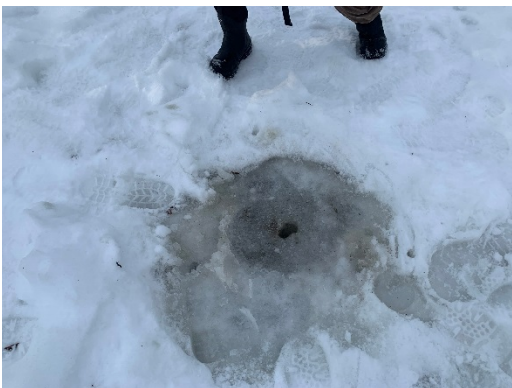
Photo 3:  
SW-5

SW5 was also drilled for ice thickness and it was determined there was approximately 24-inches of ice. We were able to sample this location using a peristaltic pump. SW17 and SW18 was also sampled with a peristaltic pump. The creek at the toe of the slope of the percolation beds was open, however it was mostly frozen over at SW18. Two holes in the ice were found to sample SW18.
