Project:	City of Wasilla WWTP Pilot Study	Field Crew:	Jake Alward, Riley Bronga, Jakob Keldsen
File:	204700415	Date:	March 22 & 25, 2019

Reference: **March Water Sampling Event**

1.1 BACKGROUND

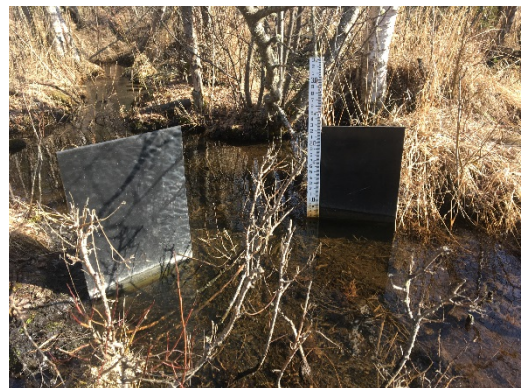
Photo 6:
SW-17

SW17 and SW18 were sampled by dipping a bottle into the stream. The ice was either completely out or mostly out at both locations. Flow data was able to be obtained for both sites.

Weir 1 (SW17)

Width: 2.21 -ft
 Water depth: 0.67 -ft
 Velocity: 0.43 -ft/sec
 Calculated flow: 0.64 -CF/sec
