Project: City of Wasilla WWTP Pilot Study Field Crew: Jake Alward, John Marshall

File: 204700415 Date: August 28 & 29, 2019

Reference: August 28 & 29 Water Sampling Event

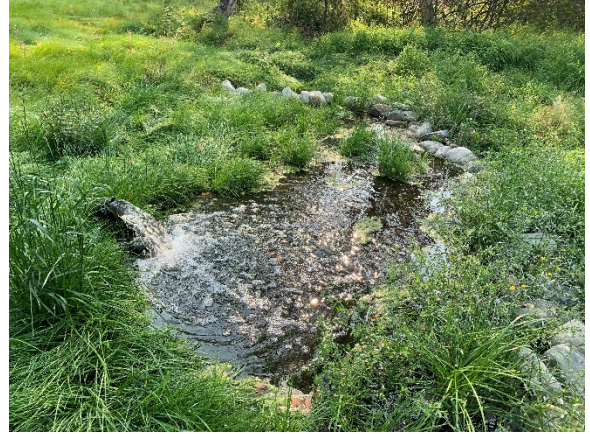
Photo 4:
Effluent Discharge

It was observed that the vegetation around the effluent discharge bed is noticeably greener and thicker than surrounding areas. There is now water pooled in the discharge bed and there is ground growing in the gravel discharge bed. The velocity of the water is still drastically cut as soon as it enters the discharge bed and therefore no erosion around the bed is present.
