Project: City of Wasilla WWTP Pilot Study      Field Crew: Jake Alward, John Marshall

File: 204700415      Date: November 19 to 20, 2019

**Reference: November Water Sampling Event**

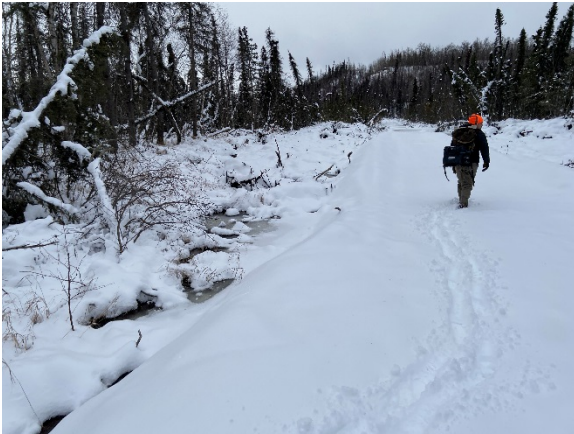
Photo 1:  
Berm

In-situ samples were also taken along the berm to determine if effluent is moving towards to west. The results are summarized below.

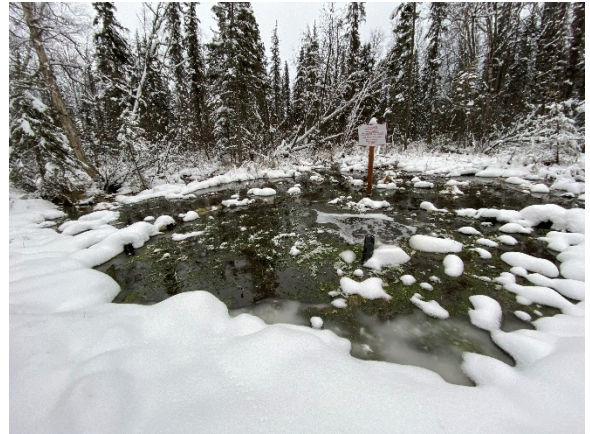
Photo 4:  
Discharge Bed #1

The location immediately adjacent to discharge bed #1 was completely unfrozen and a small amount of green vegetation was still present. The water was backed up so that the discharge bed was flooded with effluent.

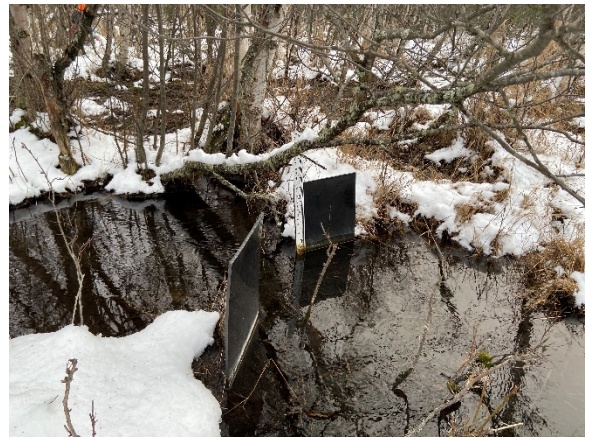
Photo 5:  
SW17

The stream near SW17 appeared to be outside of its banks more than usual. The weir flow values below confirm this observation. The flow at SW18, which appeared to be within its banks, was nearly double the flow at SW17.

November sampling went smoothly. Something to observe next month is whether the stream near SW17 is back within its normal banks.
