Project: City of Wasilla WWTP Pilot Study Field Crew: Rose Hart John Marshall

File: 204700415 Date: May 19 and 20, 2020

Reference: May Water Sampling Event

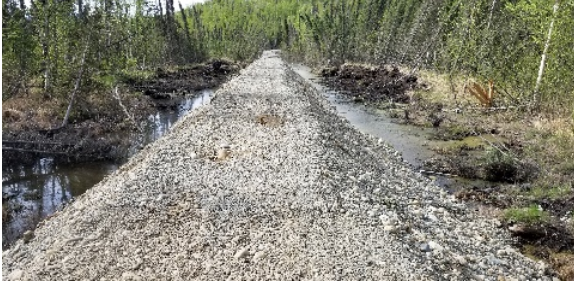
Photo 1:
Looking South Down Berm

The berm had recently been rebuilt. There were a few locations that it appears the berm is beginning to settle, however not at an alarming rate. The status of the berm will be monitored as the ground below the newly placed gravel begins to thaw.
