Project:	City of Wasilla WWTP Pilot Study	Field Crew:	Jake Alward, John Marshall, Austin Badger
File:	204700415	Date:	June 16, 2017

Reference: June Water Sampling Event

Detectable Results Summary Table

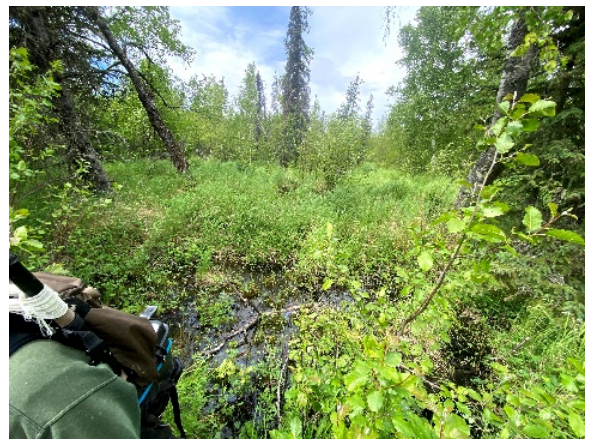
Photo 5:
SW14 - 06/17/2020

Flowing water was observed near SW11, SW12, SW14, and SW15. Said water was not particularly channelized and appeared to be meandering slowly around tussocks.
